# Safety Inspection Report

Annual Inspection

## Burnham Market Playing Field

13 August 2025

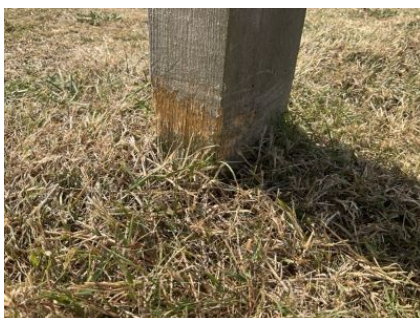
Strimmer damage is present on posts, allowing water to enter and timbers to soften. It can also remove the protective envelope around the timber. Prevent further damage and check timbers for decay throughout the year.

Prevent further damage.

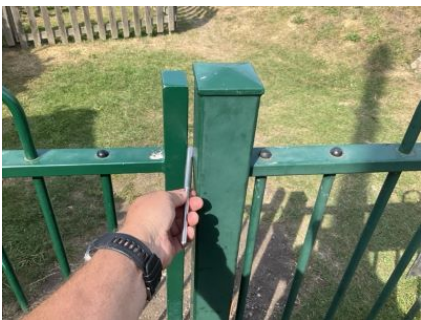
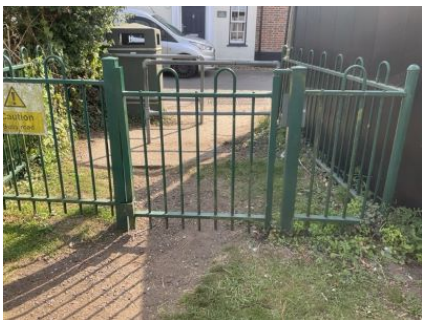
There is a crushing or shearing point on the side of the gate. Where the gaps reduce to less than 12 mm these have been known to cause serious, permanent injury to children, especially on the hinge side where the leverage forces are significant.

Main green gate is leaning. Reset.

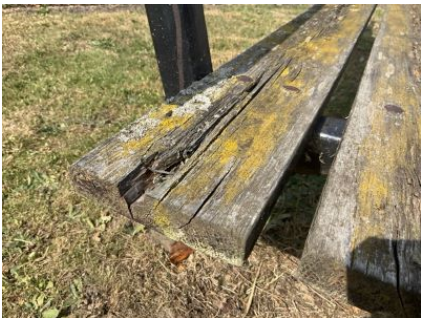
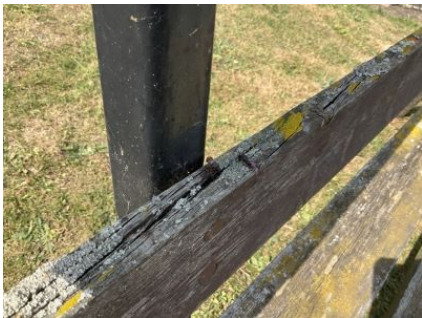
| Description |
|---|
| Timber is decayed. |
| Bench slats decaying. Replace. |

| Description |
|---|
| Replace affected parts. |

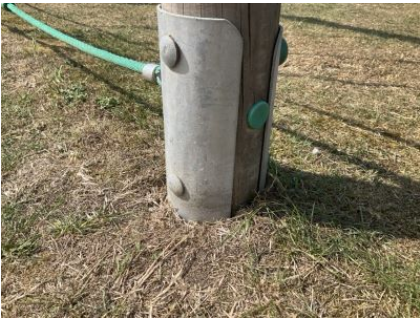
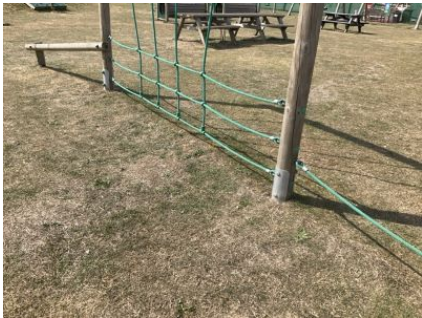
Bolt(s) loose.

Posts loose in metal shoes. General tightening of all fittings is required.

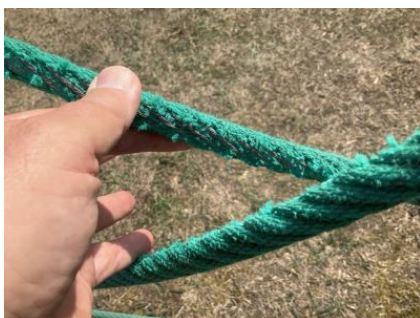
Rope wire exposed. Monitor for broken strands and sharp edges, tape over or replace if found.

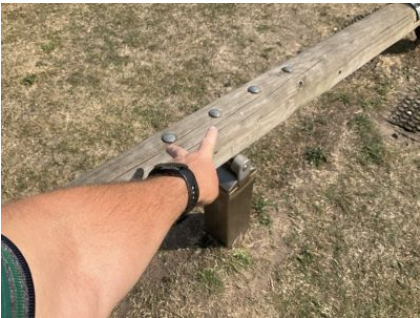
Bolt(s) loose.

Plank bolts loose. Tighten all fittings.

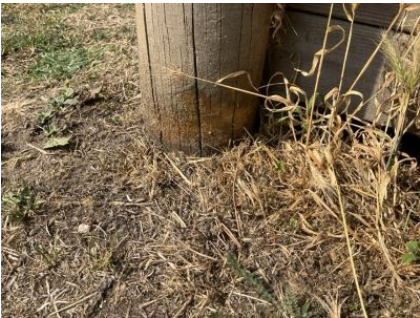
Strimmer damage is present on posts, allowing water to enter and timbers to soften. It can also remove the protective envelope around the timber. Prevent further damage and check timbers for decay throughout the year.

Prevent further damage.

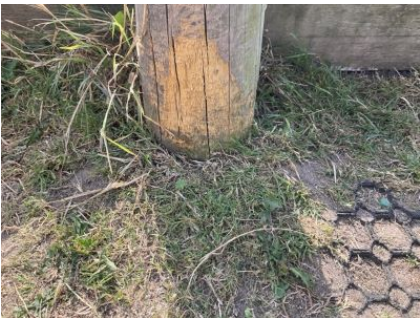
Strimmer damage is present on posts, allowing water to enter and timbers to soften. It can also remove the protective envelope around the timber. Prevent further damage and check timbers for decay throughout the year.

Prevent further damage.

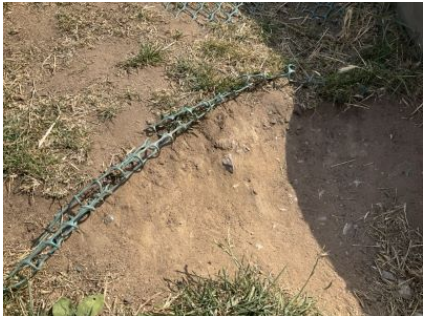
Green mesh has been damaged leaving sharp edges.  
Stones are exposed.

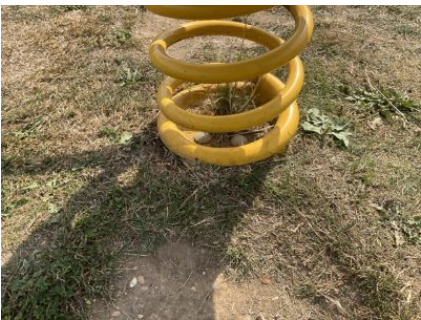
Bolt(s) loose.

Base bolts loose.

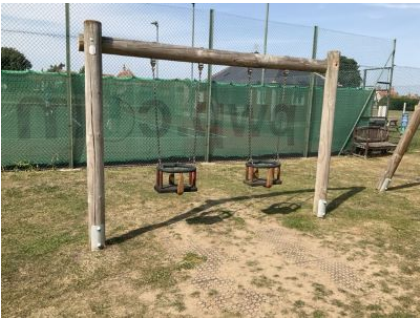
The supports are loose in the ground.

Unit loose in the ground and the post bolts are loose. Reset and tighten.

This equipment relies on one post for its stability. Special attention should be paid to maintenance (e.g. by monitoring degradation) and if necessary decommissioning the item before the end of its operating life. This is a requirement of the British Standard.

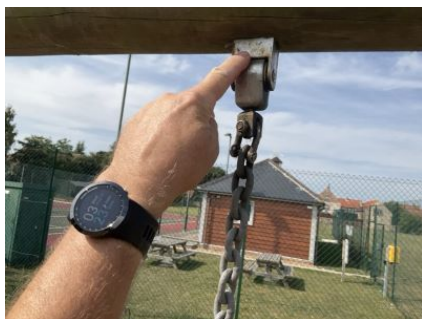
Fixtures loose or missing.

Swing hangers very loose to the top bar. Swing hanger could fall out over time if not secured correctly. Excessive movement in the top bar will lead to premature wear to both the bolts and top bar itself. Remove and inspect bolt and secure according to the manufacturer's instructions.

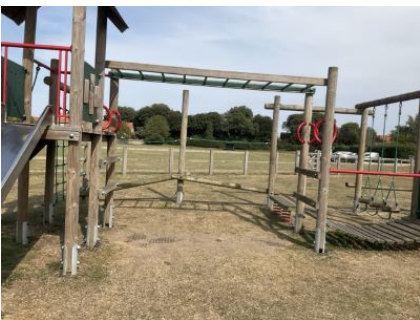
Overhead ladders and rings provide significant play value and benefits to children, and with it the risk of falling. Ensuring the surface remains in good condition will help to keep the correct balance between benefits and risk.

The protective surface under all bars and rings must be kept in good condition.
