# Safety Inspection Report

Annual Inspection

## Burnham Market Playing Field

13 August 2025

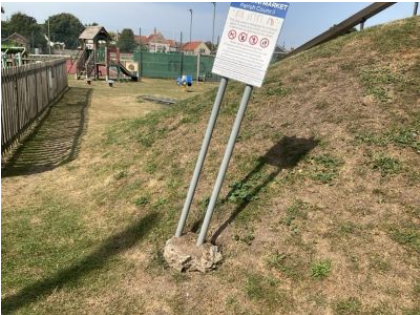
The supports are loose in the ground.

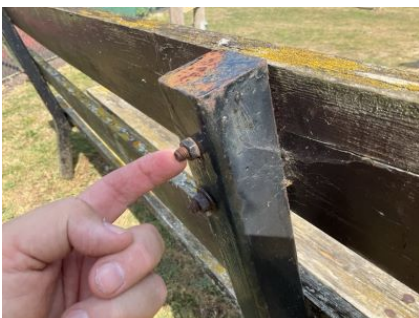
| Description |
|---|
| Timber is decayed. |
| Bench slats decaying. Replace. |

| Description |
|---|
| Replace affected parts. |

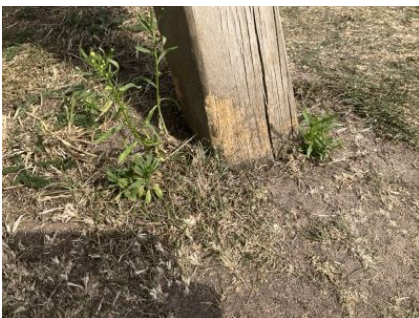
Strimmer damage is present on posts, allowing water to enter and timbers to soften. It can also remove the protective envelope around the timber. Prevent further damage and check timbers for decay throughout the year.

Prevent further damage.

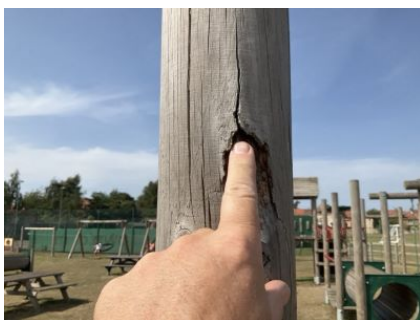
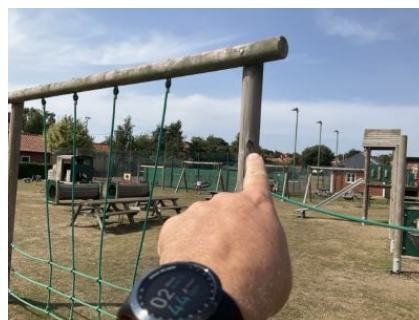
Bolt(s) loose.

Posts loose in metal shoes. General tightening of all fittings is required.

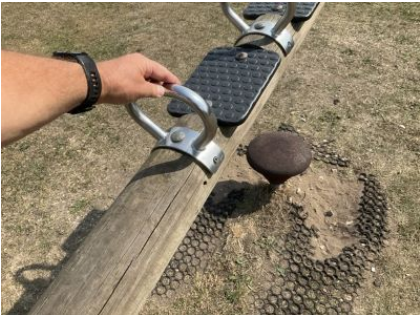
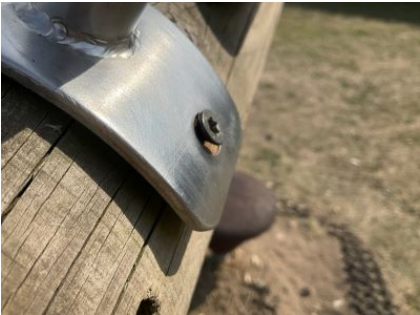
Fixtures loose or missing.

Hand grips loose to the plank.

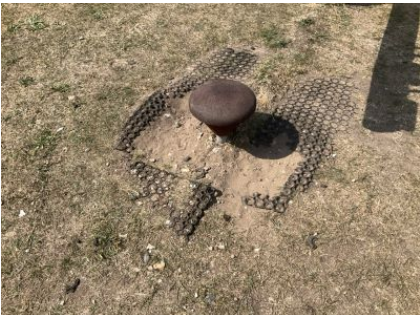
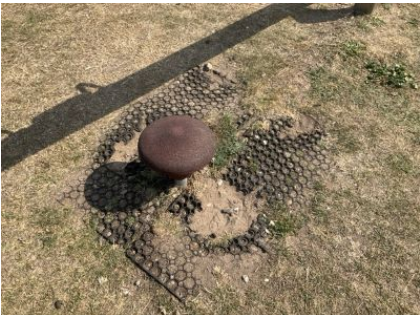
Surface needs repair.

Grass mats are damaged. Replace.

Replace.

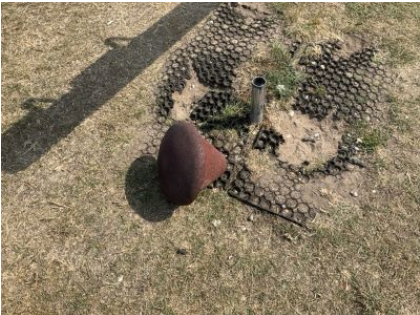
Both rubber dampeners are loose to the metal post. Re-glue and secure.

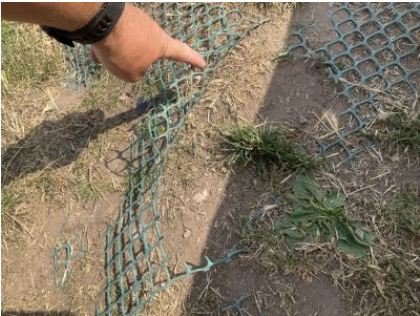
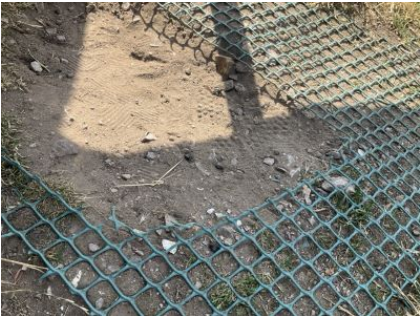
Green mesh has been damaged leaving sharp edges.  
Stones are exposed.

Risk score:  
 8

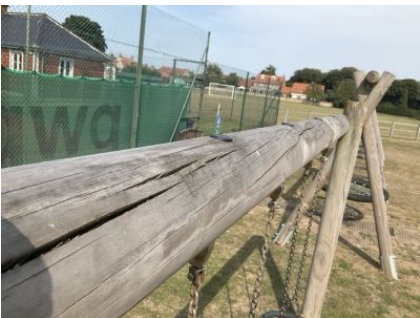
The supports are loose in the ground.

Unit loose in the ground and the post bolts are loose. Reset and tighten.

This equipment relies on one post for its stability. Special attention should be paid to maintenance (e.g. by monitoring degradation) and if necessary decommissioning the item before the end of its operating life. This is a requirement of the British Standard.

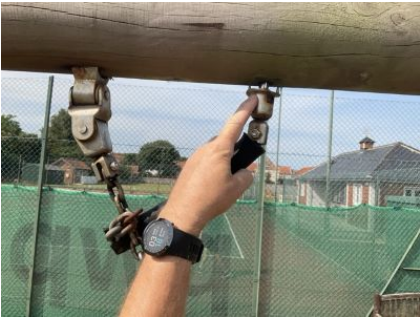
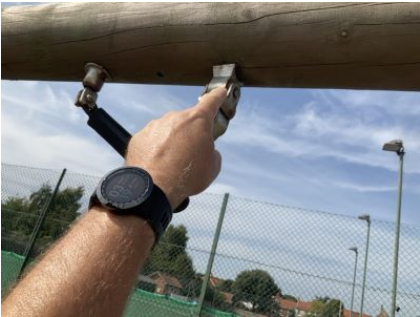
Fixtures loose or missing.

Swing hangers very loose to the top bar. Swing hanger could fall out over time if not secured correctly. Excessive movement in the top bar will lead to premature wear to both the bolts and top bar itself. Remove and inspect bolt and secure according to the manufacturer’s instructions.

10

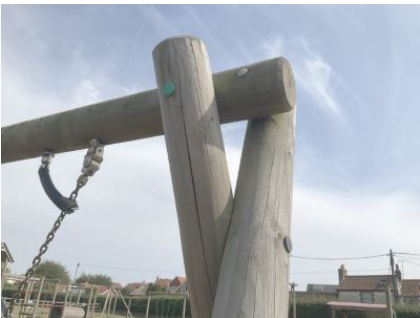
Surface needs repair.

Repair.

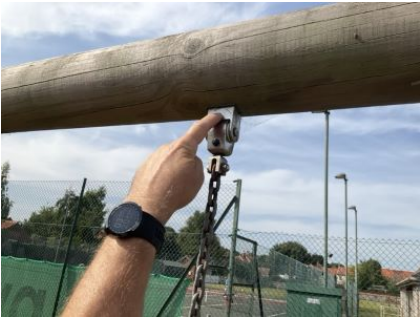
Fixtures loose or missing.

Swing hangers very loose to the top bar. Swing hanger could fall out over time if not secured correctly. Excessive movement in the top bar will lead to premature wear to both the bolts and top bar itself. Remove and inspect bolt and secure according to the manufacturer’s instructions.

10

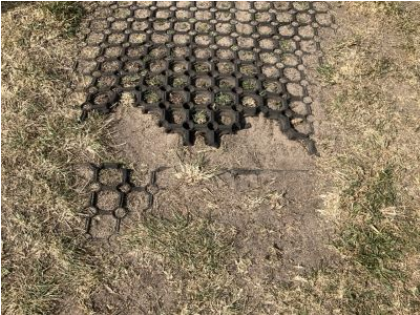
Surface needs repair.

Grass mats are damaged. Replace.

8

Repair., Replace.

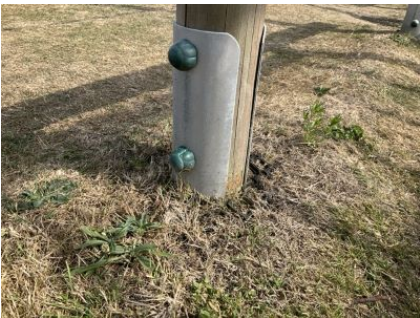
Bolt(s) loose.

Unit is rocking, posts are loose in the metal ground shoes. General tightening up of all post ground fittings.

8

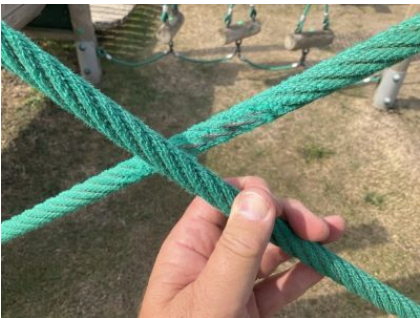
Rope wire exposed. Monitor for broken strands and sharp edges, tape over or replace if found.

Risk score:  
 4

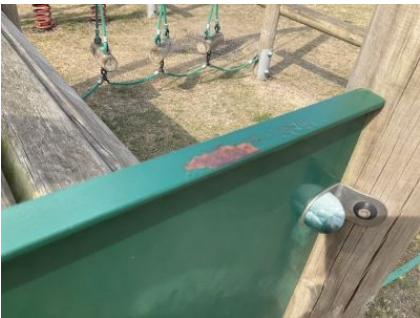
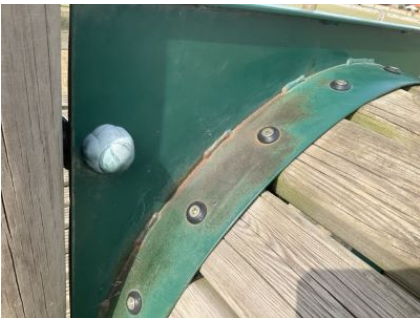
Tunnel metalwork stating to rust.

Risk score:  
 3
